PENNSYLVANIA  
VALLEY-HI EAGLE LAKE DAM

NDS I.D. No. PA - 00186  
PENNDER I.D. No. 29 - 33

PHASE I INSPECTION REPORT  
NATIONAL DAM INSPECTION PROGRAM

GAI CONSULTANTS, INC.  
570 BEATTY ROAD  
MONROEVILLE, PENNSYLVANIA 15146  
SEPTEMBER 1979

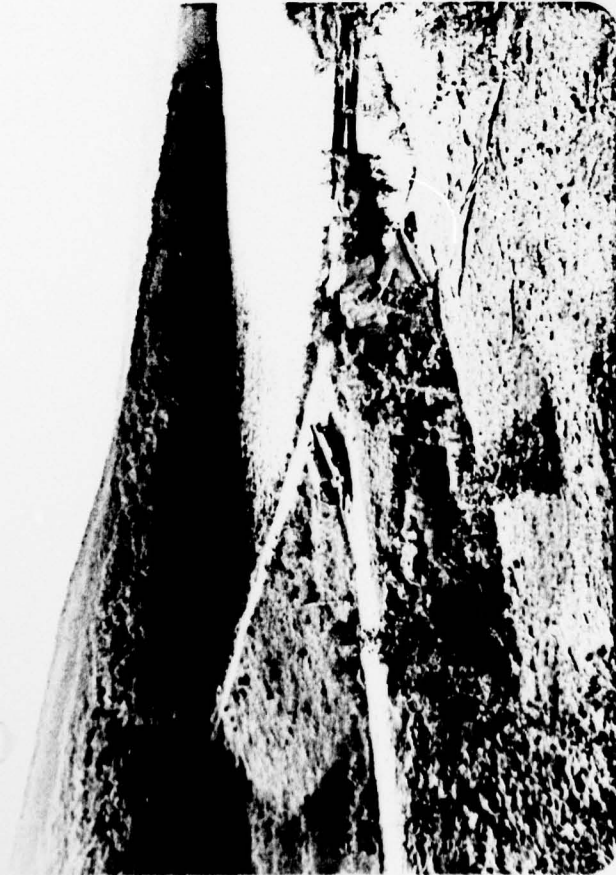
1. Spillway. The spillway, as observed during the visual inspection, appears to be in fair condition. A log bridge has been placed across the approach channel (see Photograph 4) and serves as a potential obstruction to unimpeded spillway discharge as does heavy overgrowth and boulders observed within the discharge channel (see Photograph 6). The concrete overflow weir and sidewalls show signs of cracking, scaling, and overall minor deterioration (see Photograph 4). Water was observed seeping through a crack located near the middle of the left side of the overflow weir (see Photograph 5).

PHOTOGRAPH 5    Close-up view of concrete deterioration associated with the spillway overflow weir and sidewalls.

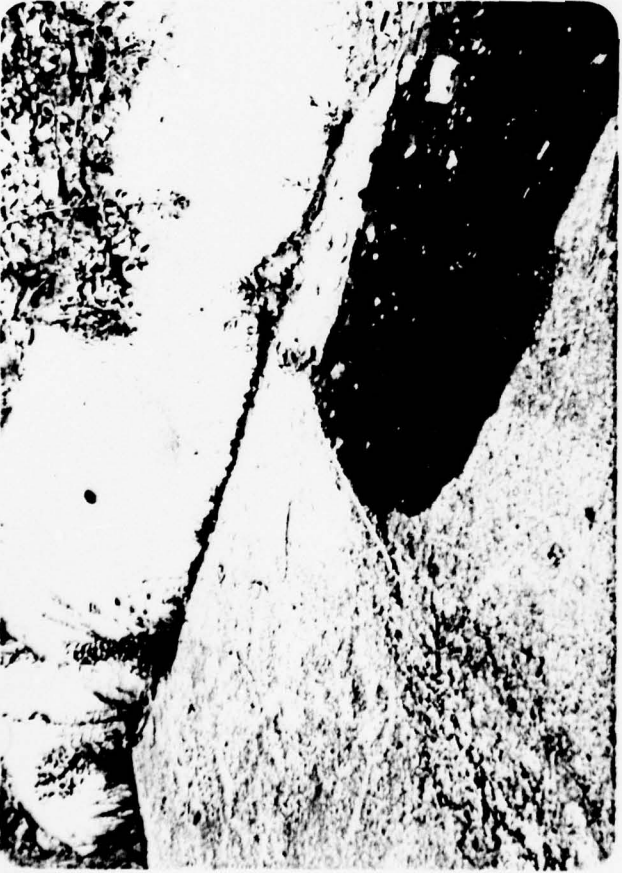
PHOTOGRAPH 9

2. Outlet Conduit. The only visible portion of the outlet conduit is its discharge end shown in Photograph 9. It is impossible to visually assess the overall condition of the conduit; however, discussions with representatives of

View of the concrete headwall and unlined channel at the discharge end of the outlet conduit located at the downstream embankment toe.

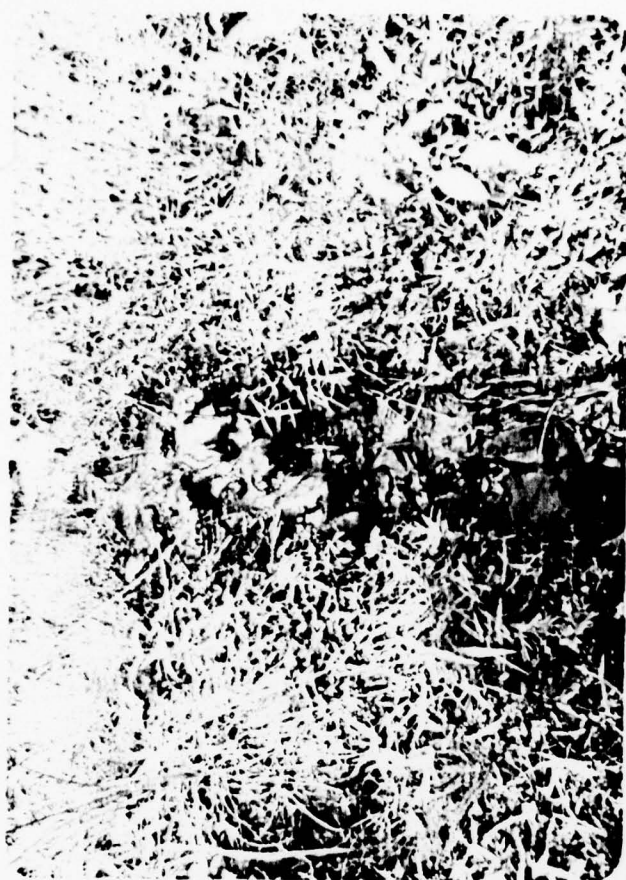
PHOTOGRAPH 12

View of one residence located near the stream along PA Route 915 approximately 4.5 miles downstream of the embankment.
